SUBJECT: LA-6 Model.

DATE: October 31, 1933.

We release herewith the third installment of Machine Service Bulletin No. 161, Plates 22 to 28 inclusive, which illustrate and describe how to adjust the mechanism not covered in the first installment of this Bulletin.

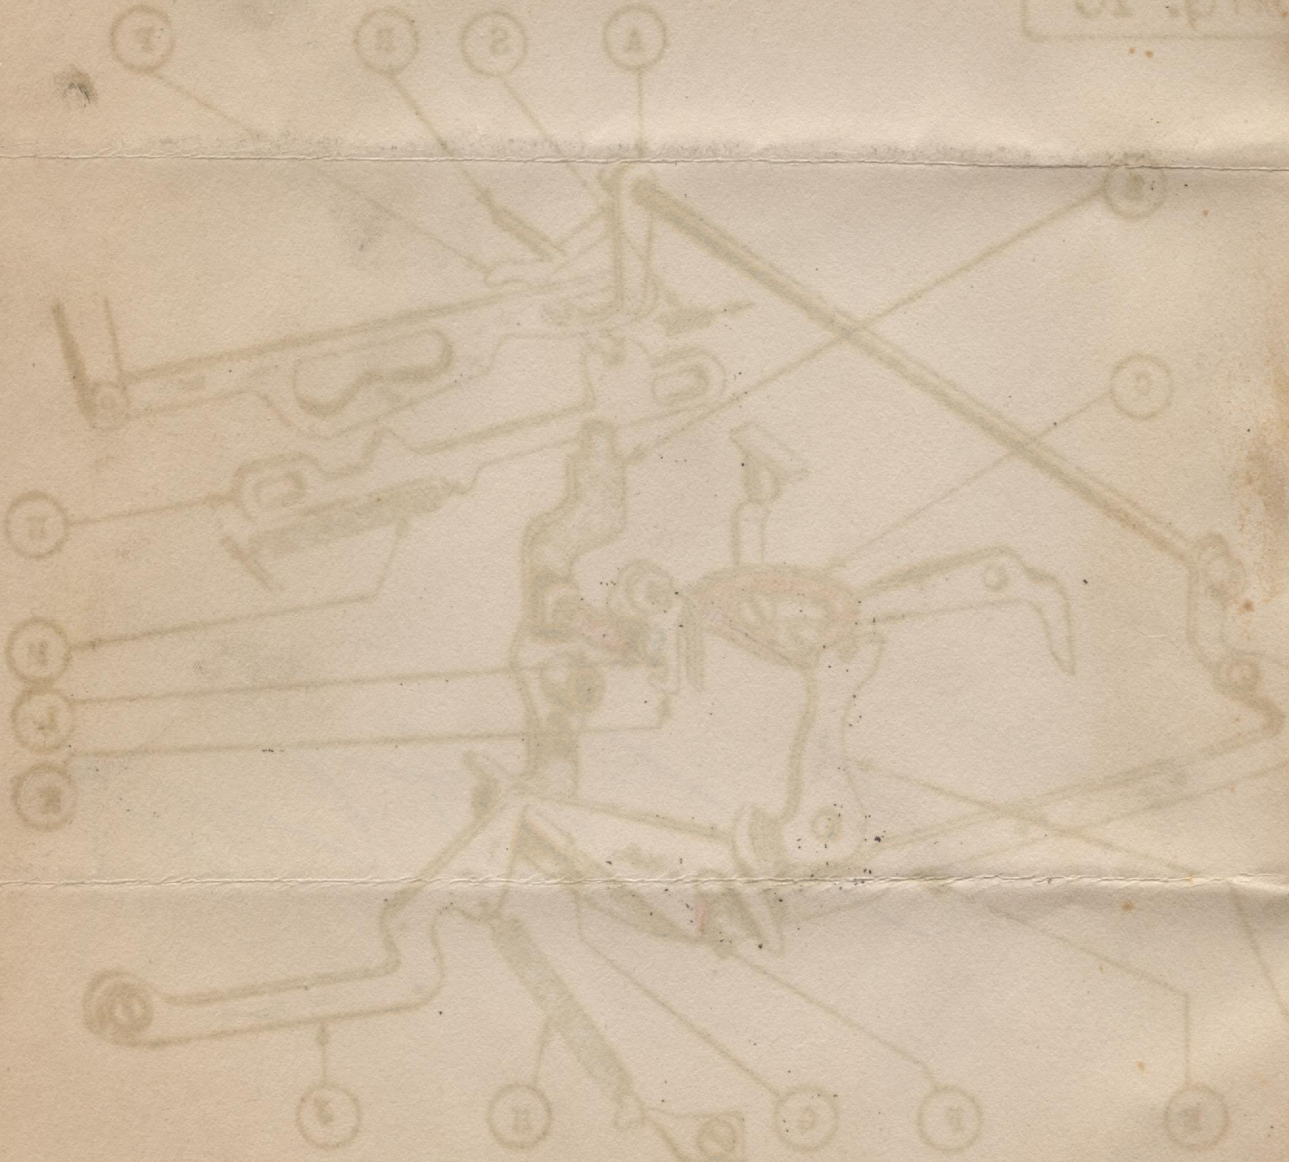
Fig. 10

To remedy a condition wherein the division lever (B) fails to restore or restores sluggishly, a button of .040 thickness (L) has been added to the guide blank (K). This prevents the blank (C) from camming out of engagement with the restoring arm (D) as shown.

When the lever (N) falls to its normal position, the piston (L) has been moved to the right, causing the lever (N) to fall to its normal position. This prevents the piston (L) from being out of engagement with the restoring arm (D) as shown.

Do not change the original tension of springs (M) and (N) as additional tension increases the load of restoring the division lever.
